## Idaho Transportation Department Bridge Inspection Report

Bridge Key:	29263	Structure Name:	X994250 16.15
(6)Features Intersected:	UPPER CROOKED RIVER	(9)Location:	30.2 E 12.6 S GRANGEVILLE
Facility Carried(Route):	CROOKED RIVER ROAD	Admin Jurisdiction:	4900 Idaho County
Xref Structure Name:		District:	02

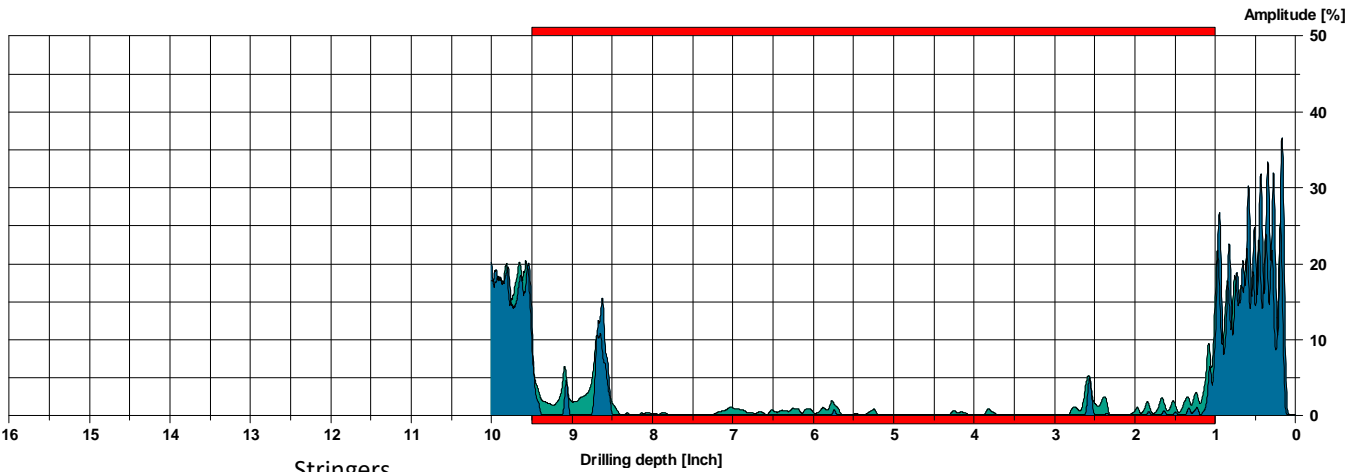
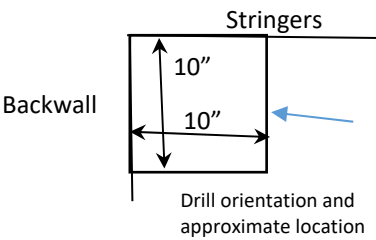
Drill: E-1023-01

**Unit:** South Abutment      **Member:** Fourth timber from the top  
**Location:** 1' from southwest corner of abutment.  
**Inspector Interpreted Profile:**  
8.5" of rot detected from 1" to 9.5".

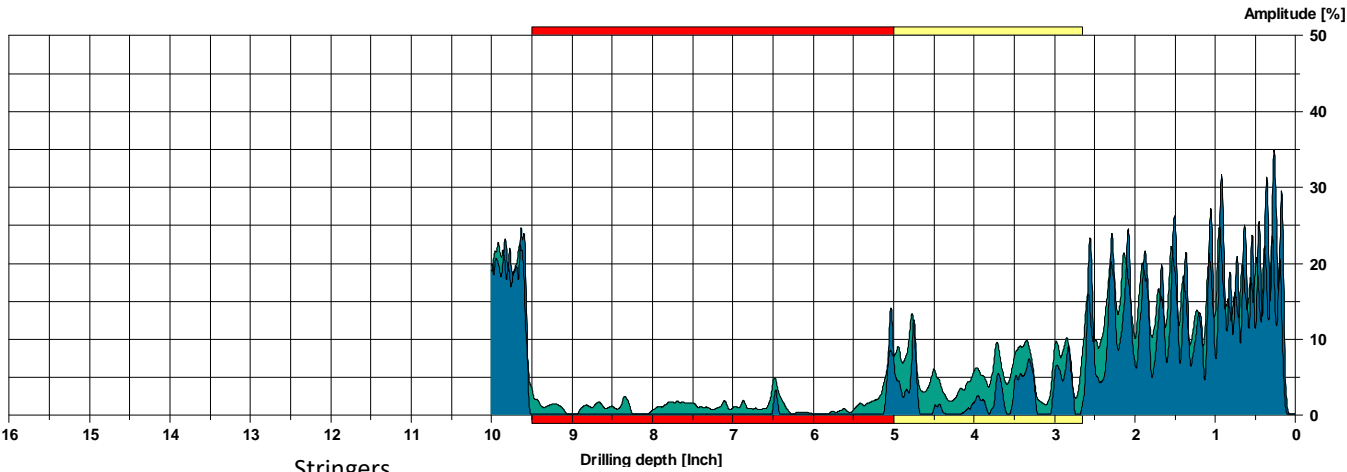
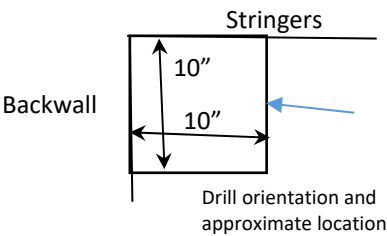
Drill: E-1023-02

**Unit:** South Abutment      **Member:** Fourth timber from the top  
**Location:** 4' from southwest corner of abutment.  
**Inspector Interpreted Profile:**  
5.5" of rot detected with soft wood from 2.6" to 5".

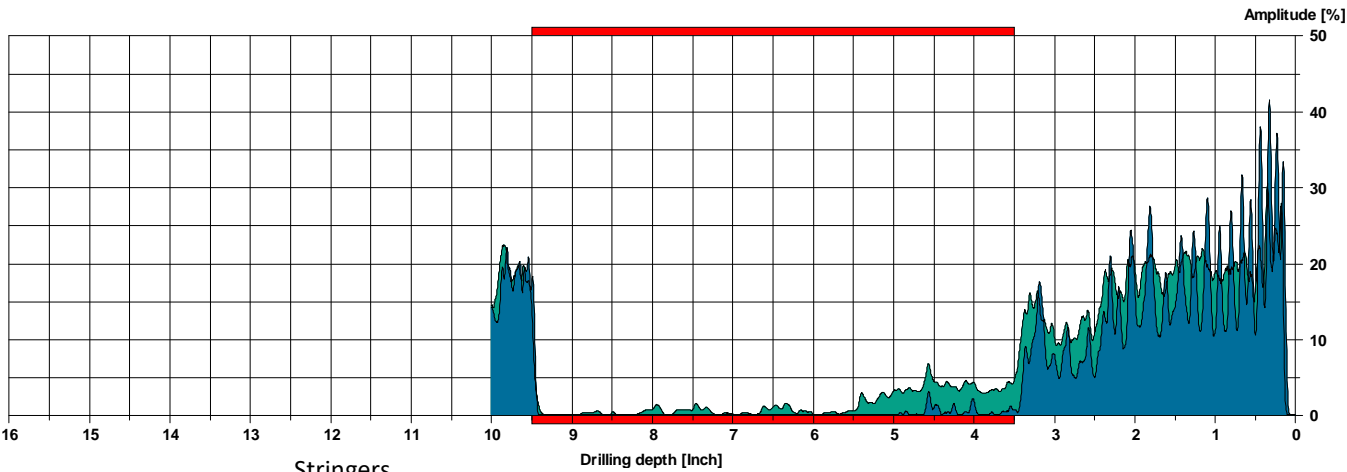
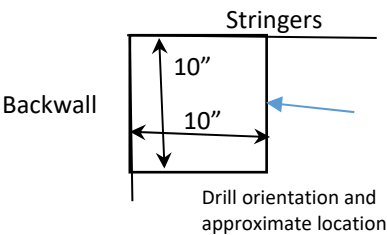
Drill: E-1023-03

**Unit:** South Abutment      **Member:** Fourth timber from the top  
**Location:** 7' from southwest corner of abutment.  
**Inspector Interpreted Profile:**  
6" of rot detected from 3.5" to 9.5".

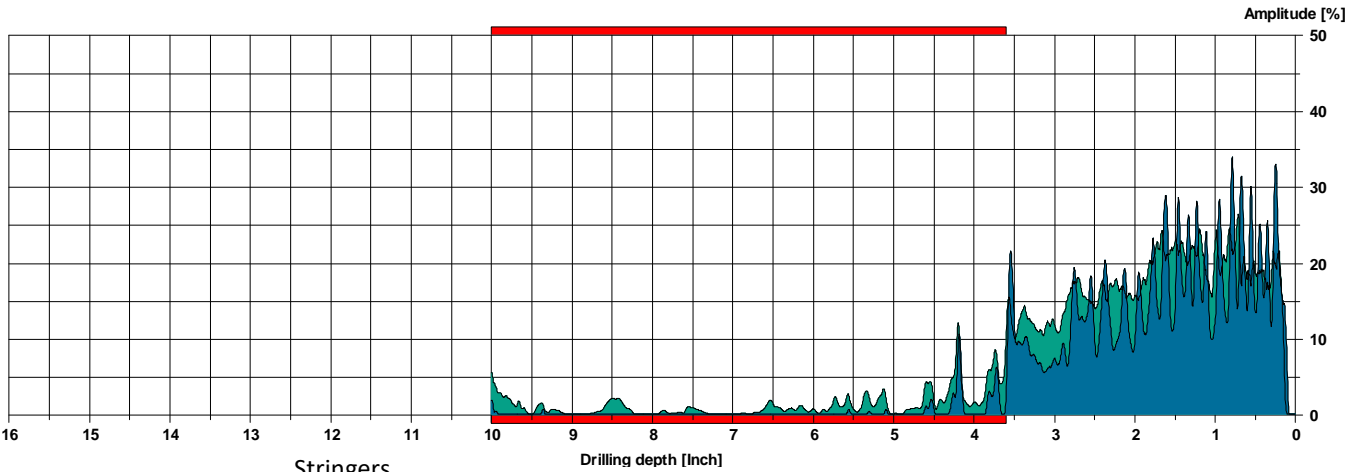
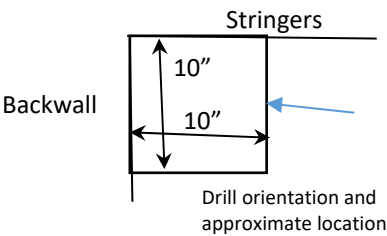
Drill: E-1023-04

**Unit:** South Abutment      **Member:** Fourth timber from the top  
**Location:** 10' from southwest corner of abutment.  
**Inspector Interpreted Profile:**  
6.4" of rot detected from 3.6" to 10".

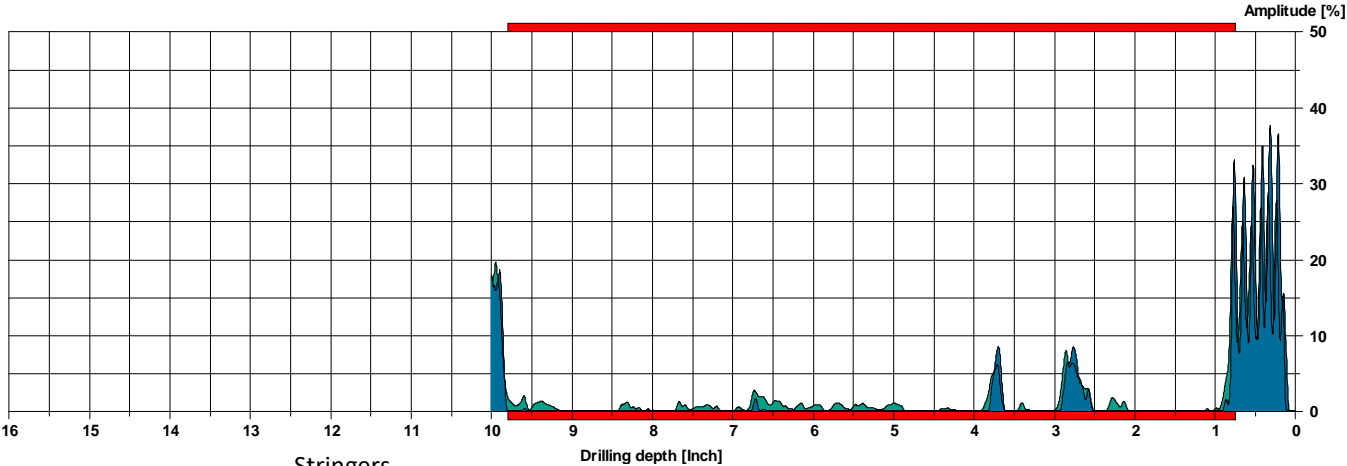
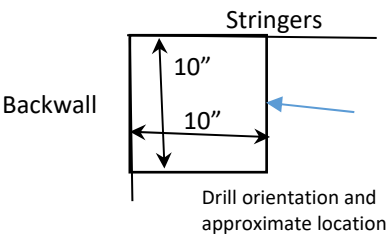
Drill: E-1023-05

**Unit:** South Abutment      **Member:** Fourth timber from the top  
**Location:** 13' from southwest corner of abutment.  
**Inspector Interpreted Profile:**  
9" of rot detected from 0.75" to 9.8".

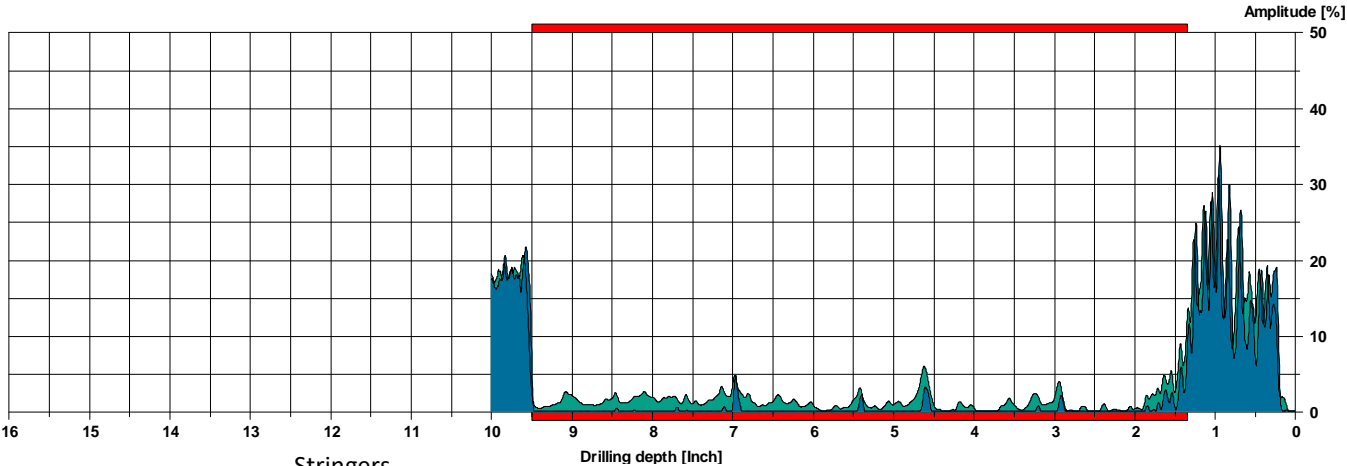
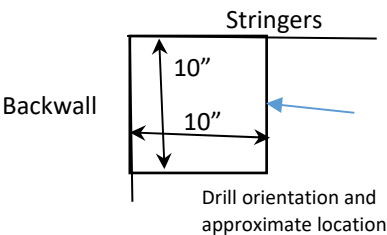
Drill: E-1023-06

**Unit:** South Abutment      **Member:** Fourth timber from the top  
**Location:** 16' from southwest corner of abutment.  
**Inspector Interpreted Profile:**  
9" of rot detected from 1.35" to 9.5".

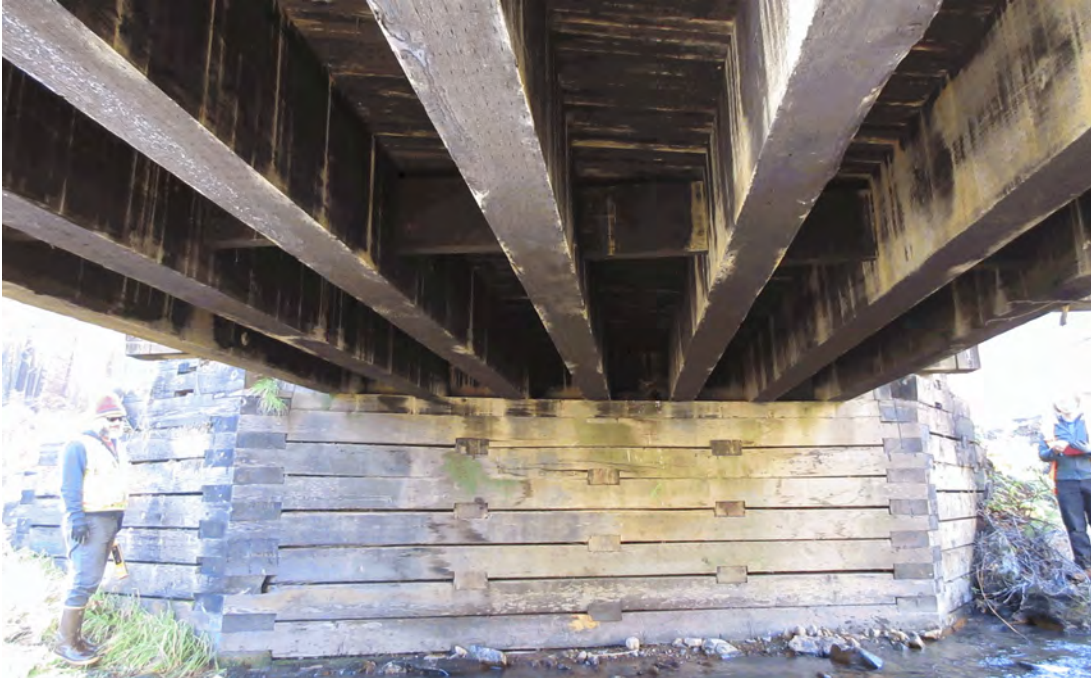
*The abutments are in poor condition and the south abutment is actively failing, due to rot, crushed timber, and sliding from back pressure.*

Soffit, superstructure, south abutment, and channel. The abutment has rot and shifting; the top has 1.5-inch settlement.

Recommendation	Priority	Suggested Work Assignment
Repair/replace the abutments.	High	Local Agency

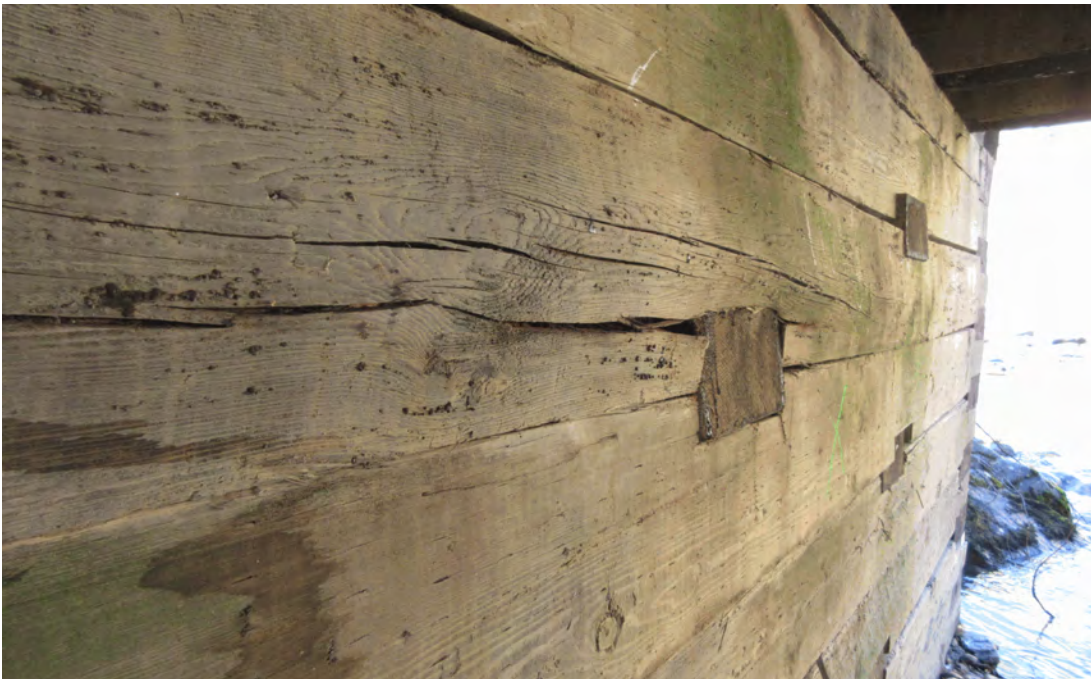
*(CS4) South abutment: 3rd timber from the top is fully rotten and has crushing and bulging with splits; it has collapsed by 1-inch.*

*(CS4) South abutment: 4th timber from the top is fully rotten and has a 1.5-inch offset.*

(CS4) South abutment: the third and fourth timbers from the top are fully rotten; the third timber has crushing.

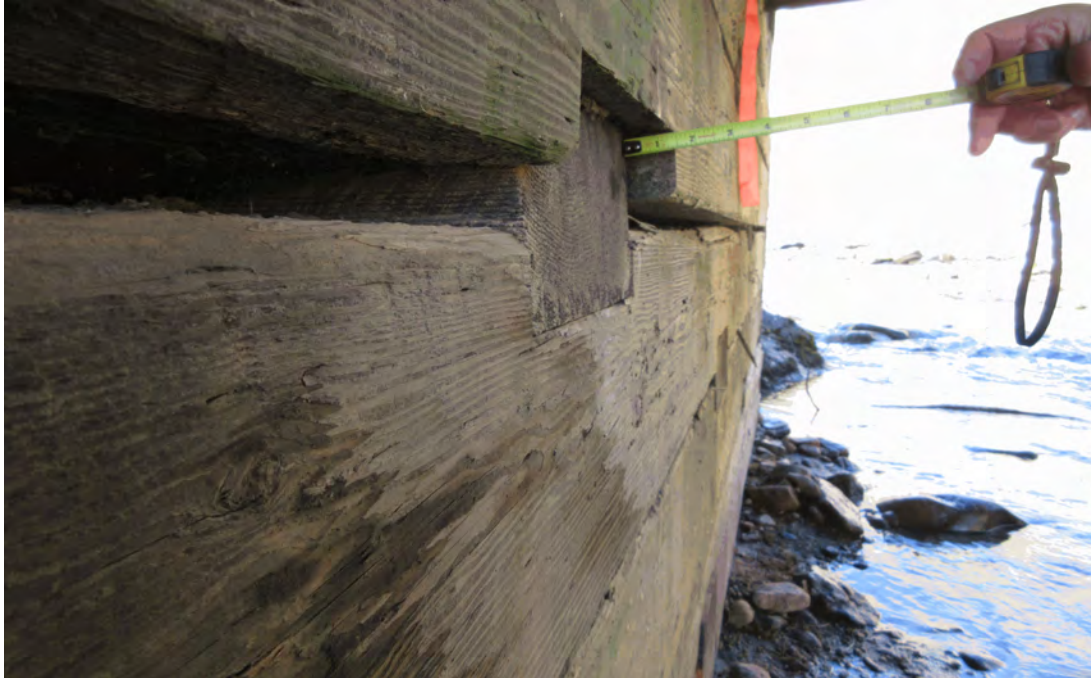
(CS4) South abutment: the 4th beam from the top has a 1.5-inch offset.

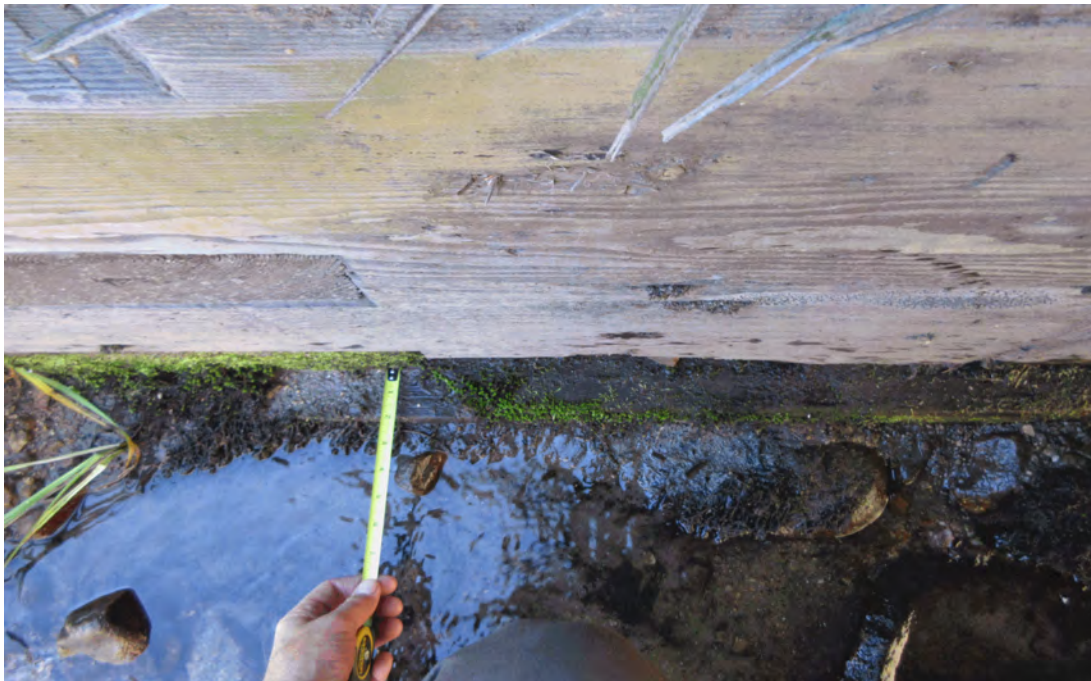
(CS4) South abutment: the bottom timber has a 2-inch offset.

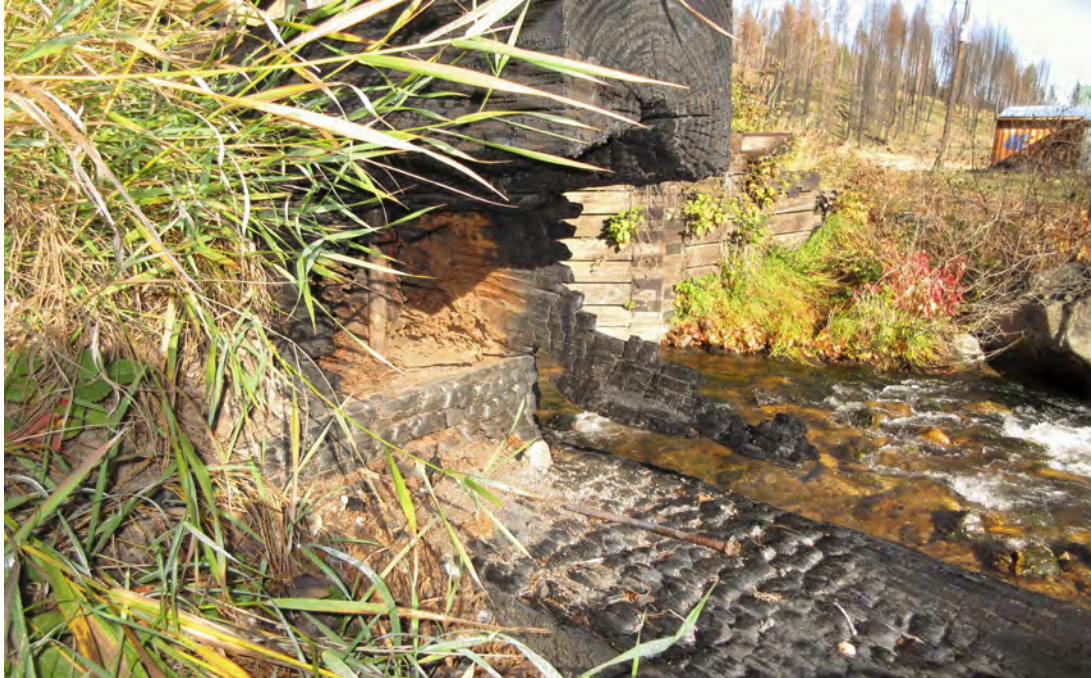
*(CS4) The wingwalls have all been heavily effected by the wildfire and are burnt to 50% structurally ineffective. The ends are particularly burnt and the timbers are cracked in half.*

(CS4) SE wingwall: the timber is heavily burnt.

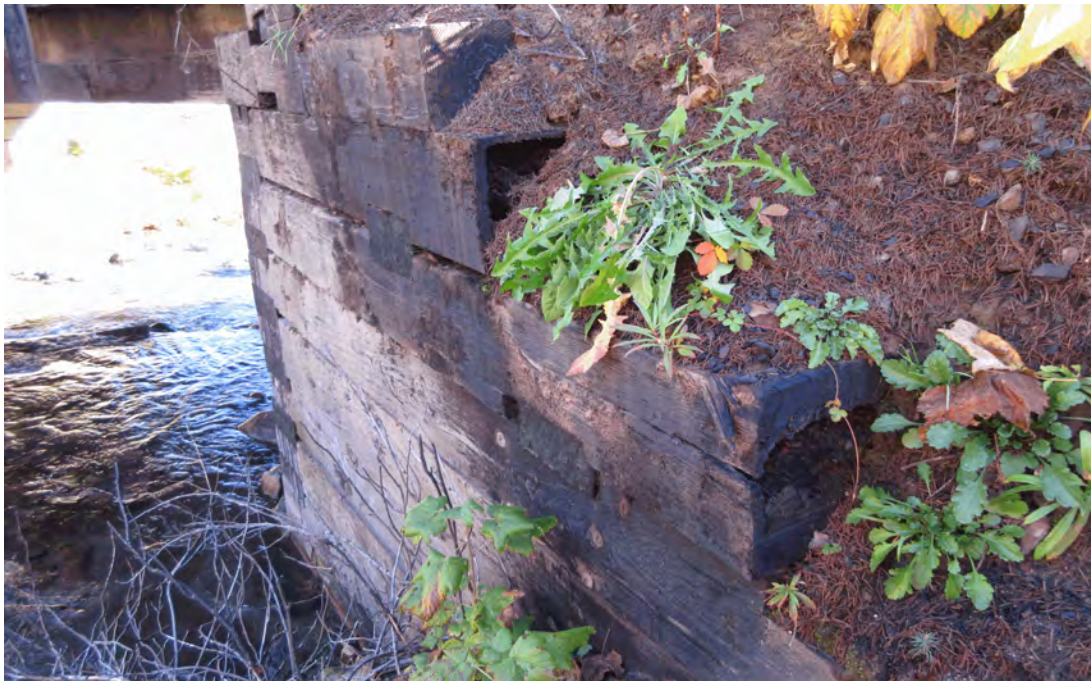
*(CS3) SW wingwall: structural failure from the burn with a 5-degree tilt.*

SW wingwall: (CS4) the timber is heavily burnt and is (CS3) leaning 5-degrees.

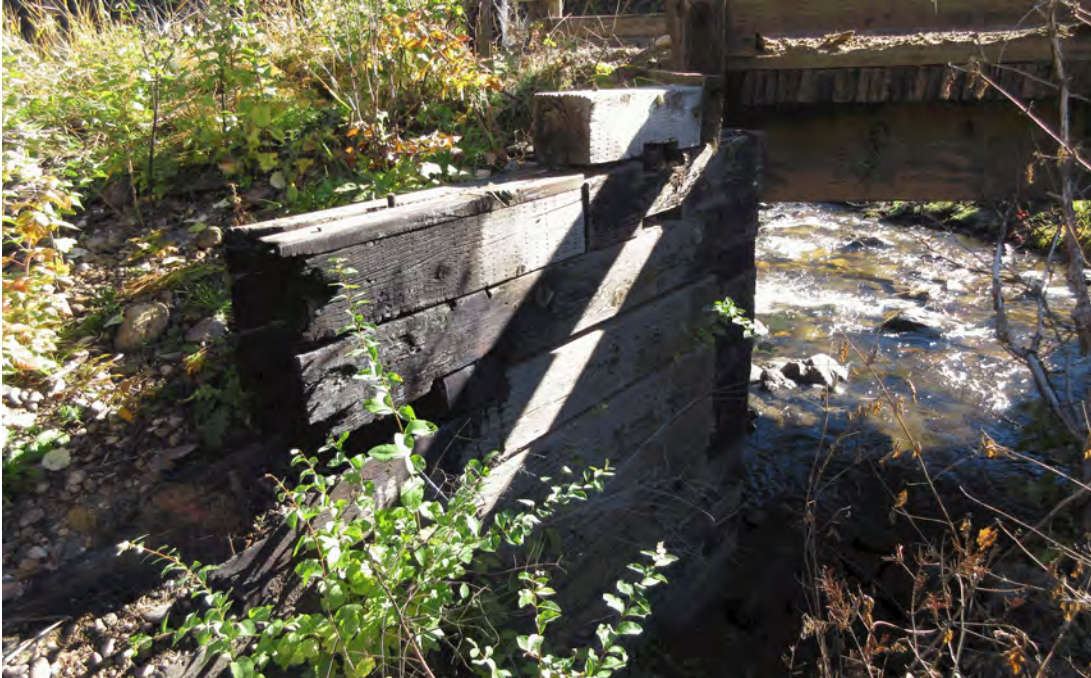
(CS4) NW wingwall: the timber is heavily burnt.

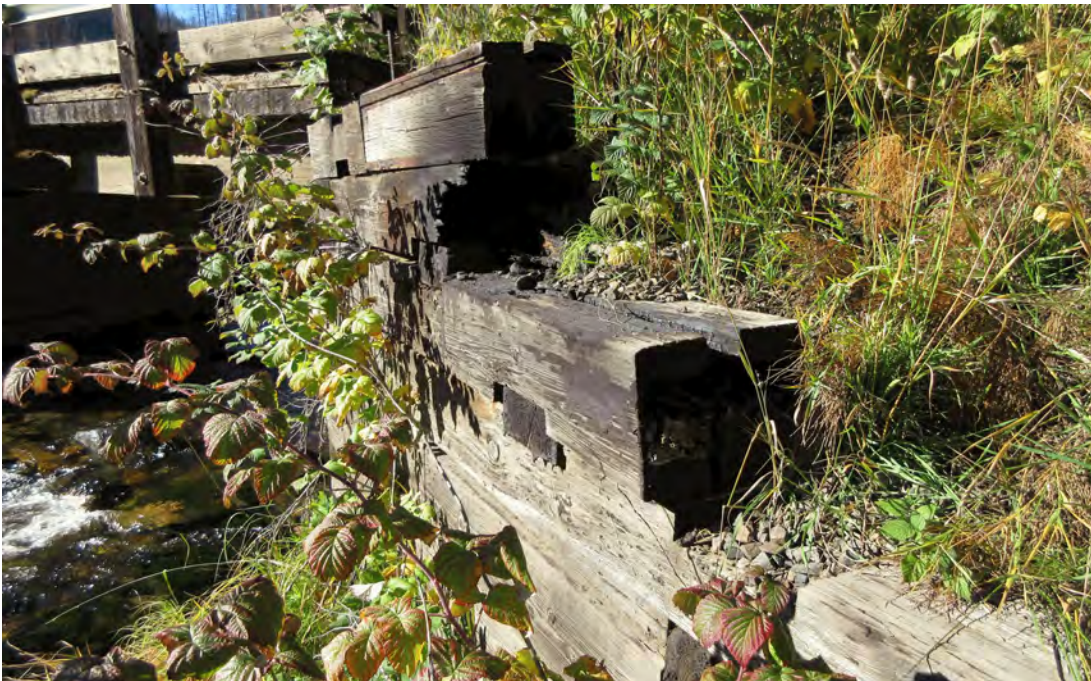
(CS4) NE wingwall: the timber is heavily burnt.

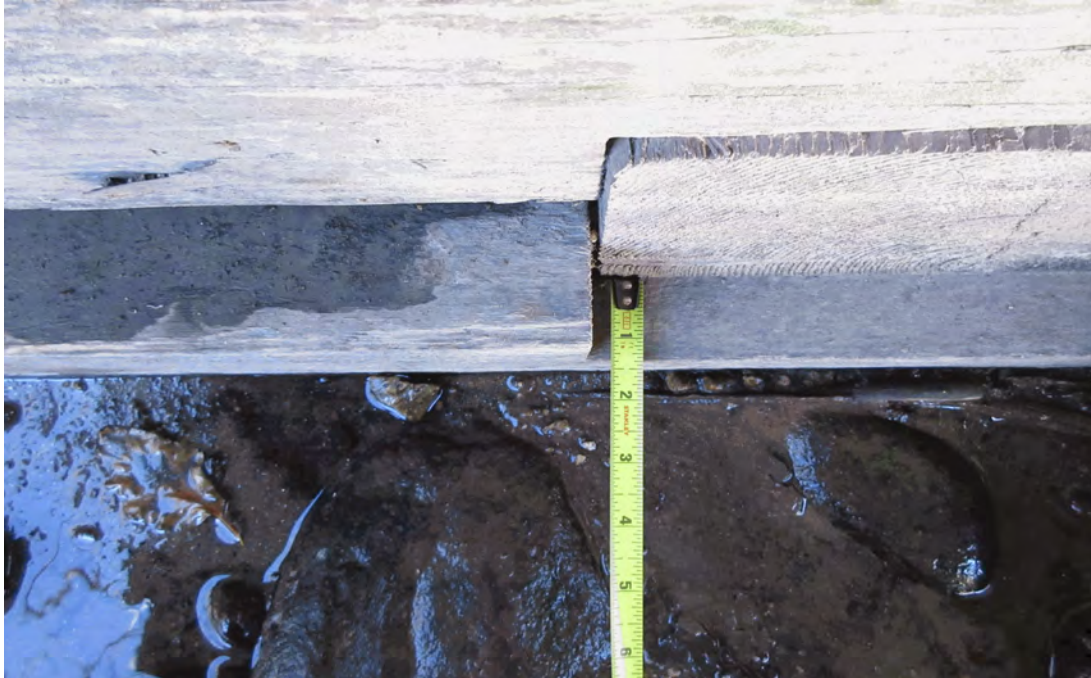
(CS4) North abutment: the bottom timber has a 1.5-inch offset.
