## Idaho Transportation Department Bridge Inspection Report

Bridge Key:	29263	Structure Name:	X994250 16.15
(6)Features Intersected:	UPPER CROOKED RIVER	(9)Location:	30.2 E 12.6 S GRANGEVILLE
Facility Carried(Route):	CROOKED RIVER ROAD	Admin Jurisdiction:	4900 Idaho County
Xref Structure Name:		District:	02

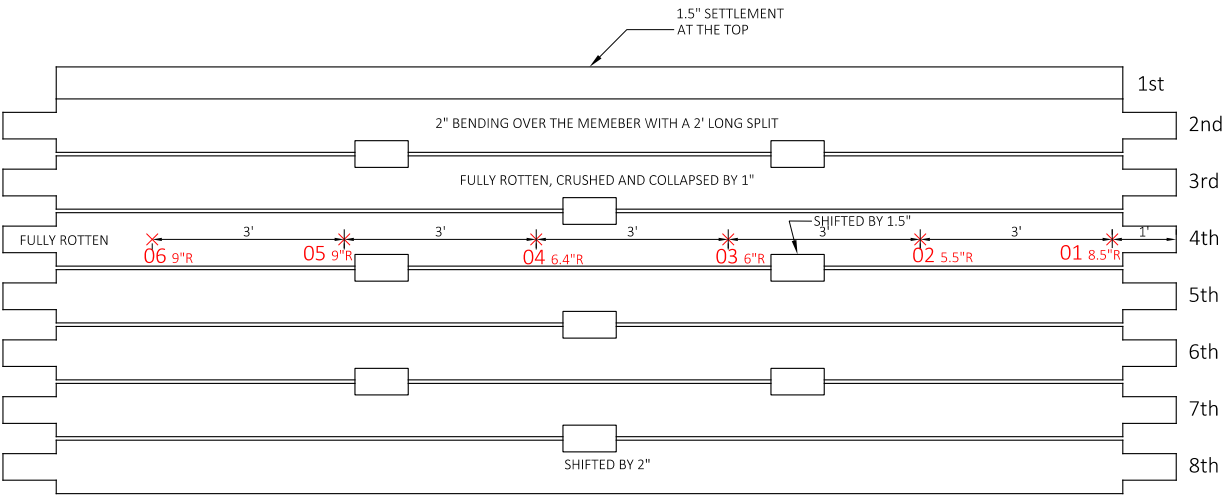
SOUTH ABUTMENT  
1" : 3'

*(CS4) South abutment, 4th timber from top: 2023 Resistance drilling found rot up to 9-inch-wide.*

**Unit:** South Abutment      **Member:** Fourth timber from the top  
**Location:** 1' from southwest corner of abutment.  
**Inspector Interpreted Profile:**  
8.5" of rot detected from 1" to 9.5".

**Unit:** South Abutment      **Member:** Fourth timber from the top  
**Location:** 4' from southwest corner of abutment.  
**Inspector Interpreted Profile:**  
5.5" of rot detected with soft wood from 2.6" to 5".

**Unit:** South Abutment      **Member:** Fourth timber from the top  
**Location:** 7' from southwest corner of abutment.  
**Inspector Interpreted Profile:**  
6" of rot detected from 3.5" to 9.5".

**Unit:** South Abutment      **Member:** Fourth timber from the top  
**Location:** 10' from southwest corner of abutment.  
**Inspector Interpreted Profile:**  
6.4" of rot detected from 3.6" to 10".

**Unit:** South Abutment      **Member:** Fourth timber from the top  
**Location:** 13' from southwest corner of abutment.  
**Inspector Interpreted Profile:**  
9" of rot detected from 0.75" to 9.8".

**Unit:** South Abutment      **Member:** Fourth timber from the top  
**Location:** 16' from southwest corner of abutment.  
**Inspector Interpreted Profile:**  
9" of rot detected from 1.35" to 9.5".

Recommendation	Priority	Suggested Work Assignment
Repair/replace the abutments.	High	Local Agency

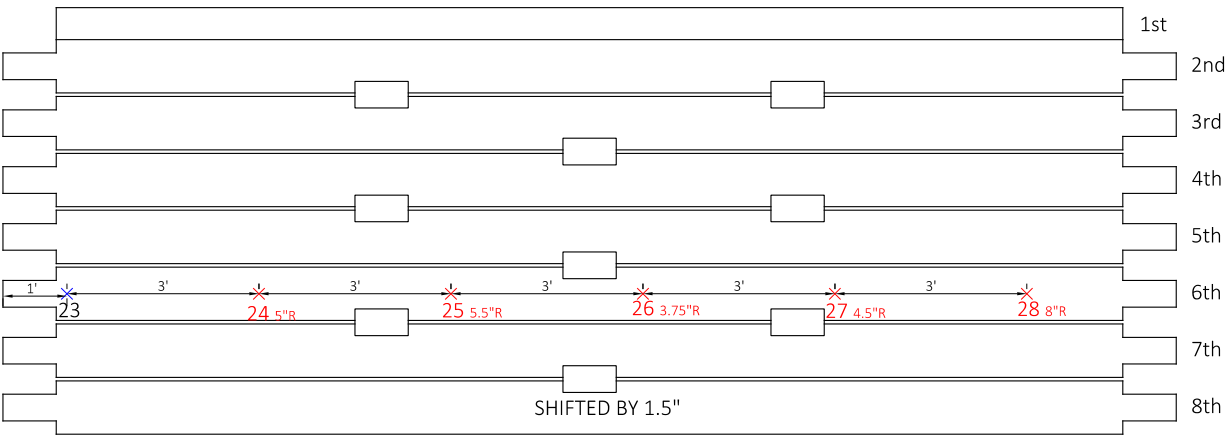
NORTH ABUTMENT  
1" : 3'

*(CS4) North abutment, 6th timber from top: 2023 Resistance drilling found rot up to 8-inch-wide.*

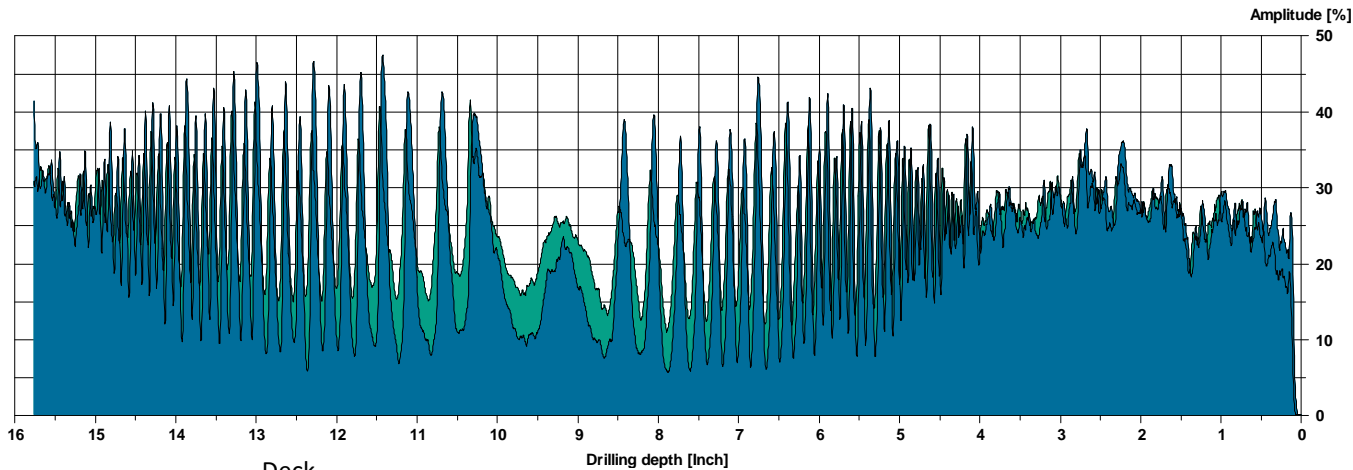
Drill: E-1023-07

Span: 1    Member: Beam 1  
Location: 1' from the south abutment.  
Inspector Interpreted Profile:  
No rot detected.

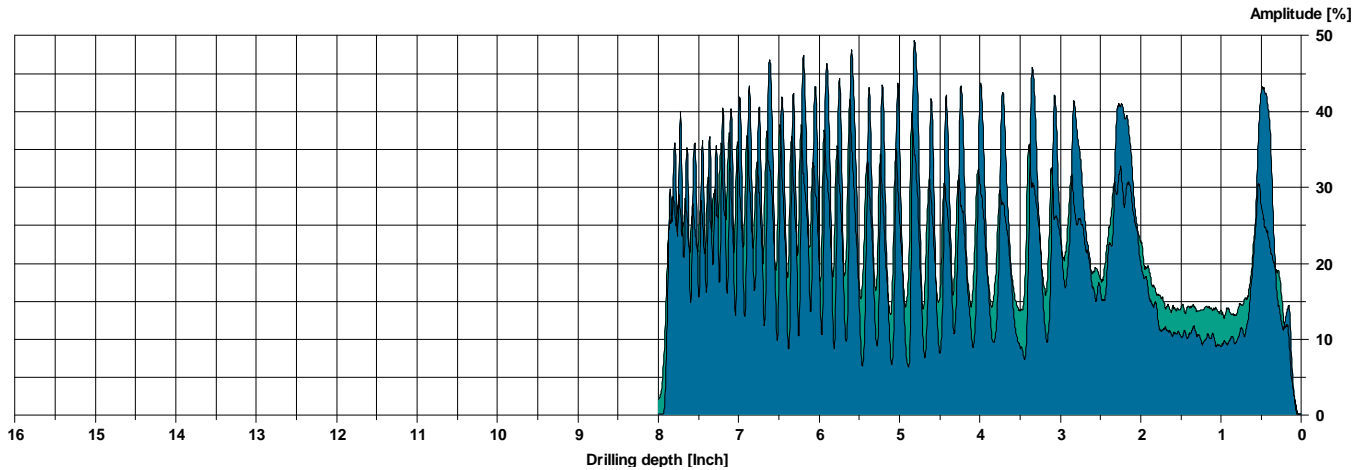
Drill: E-1023-08

Span: 1    Member: Beam 1  
Location: 1' from the south abutment.  
Inspector Interpreted Profile:  
No rot detected.

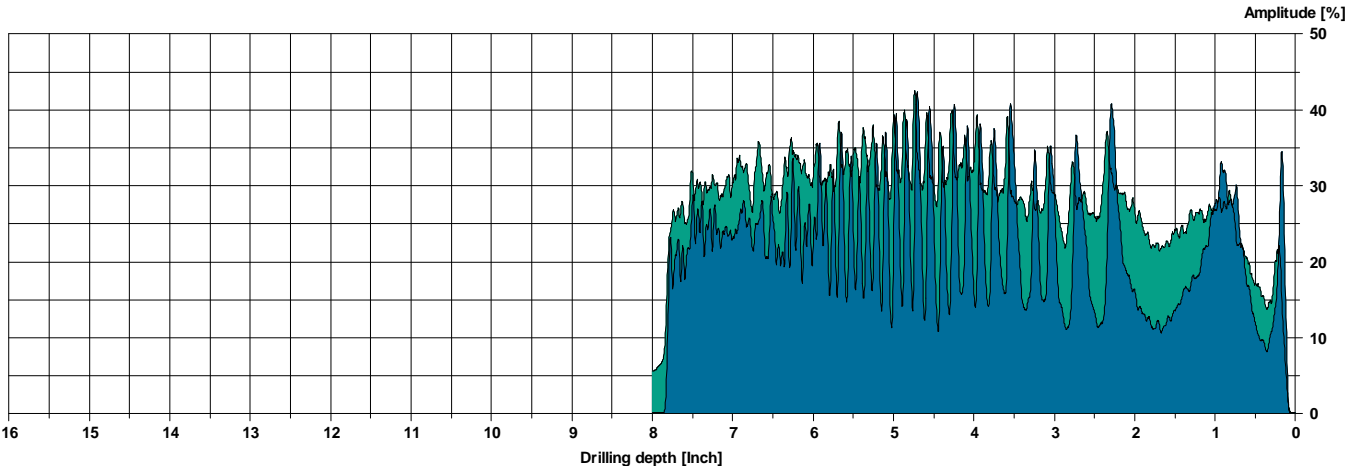
Drill: E-1023-09

**Span: 1    Member: Beam 1**  
**Location: 4' from the south abutment.**  
**Inspector Interpreted Profile:**  
No rot detected.

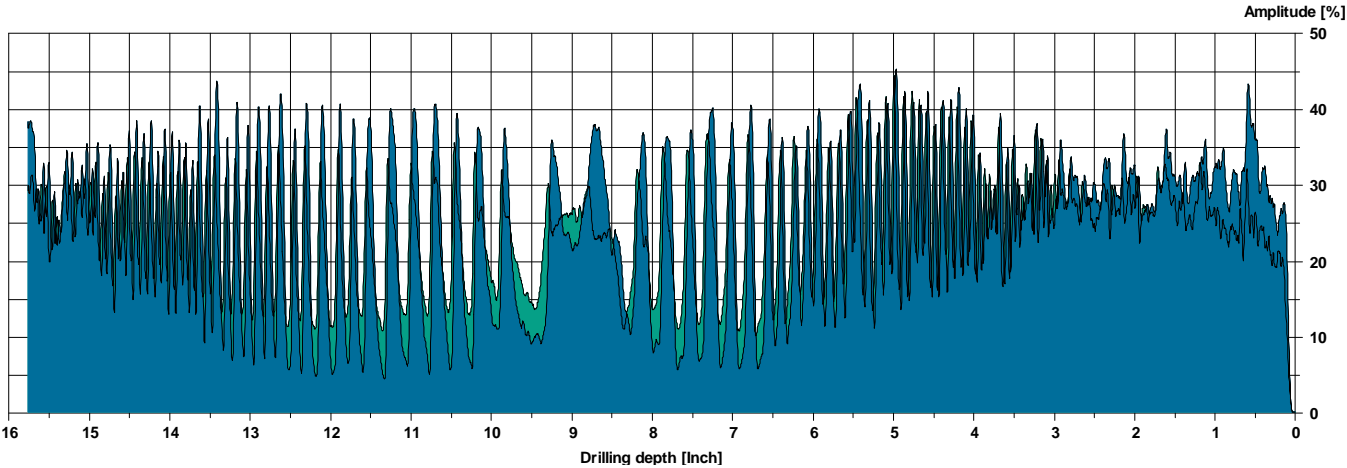
Drill: E-1023-10

**Span: 1    Member: Beam 1**  
**Location: 4' from the south abutment.**  
**Inspector Interpreted Profile:**  
No rot detected.

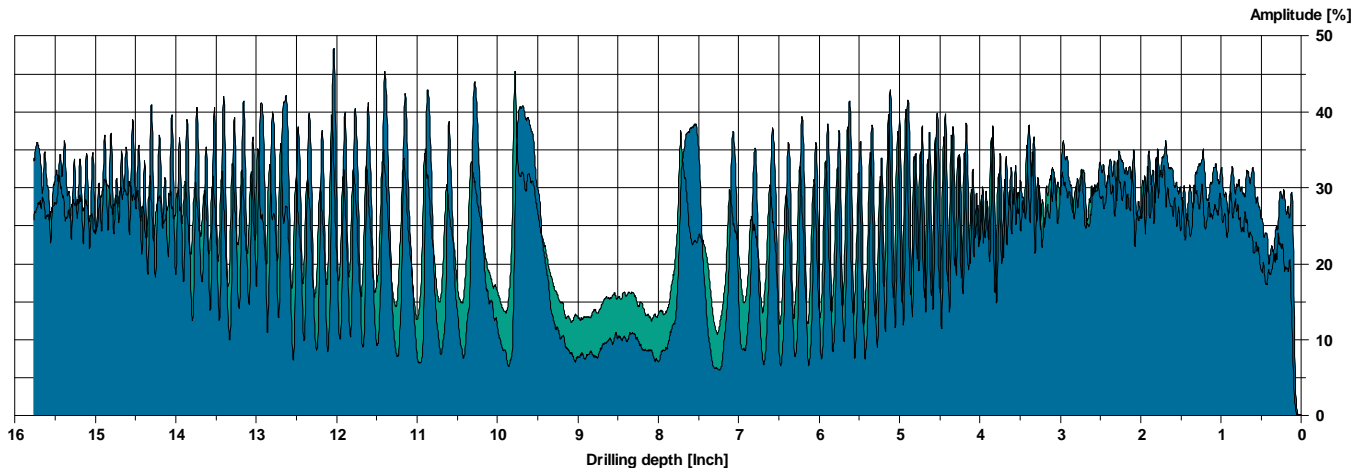
Drill: E-1023-11

Span: 1 Member: Beam 1  
Location: 7' from the south abutment.  
Inspector Interpreted Profile:  
No rot detected.

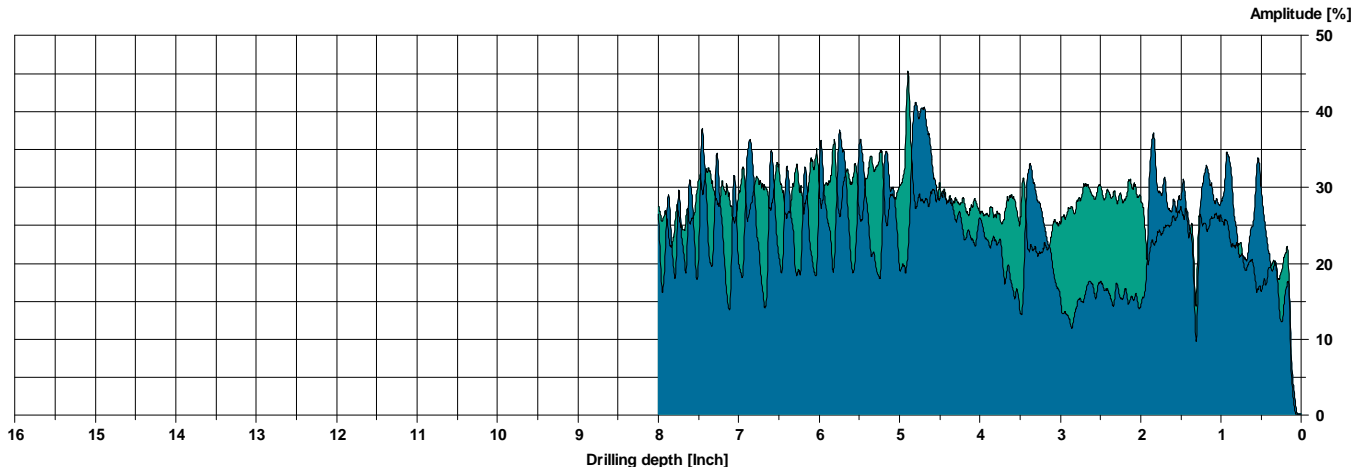
Drill: E-1023-12

Span: 1 Member: Beam 1  
Location: 7' from the south abutment.  
Inspector Interpreted Profile:  
No rot detected.

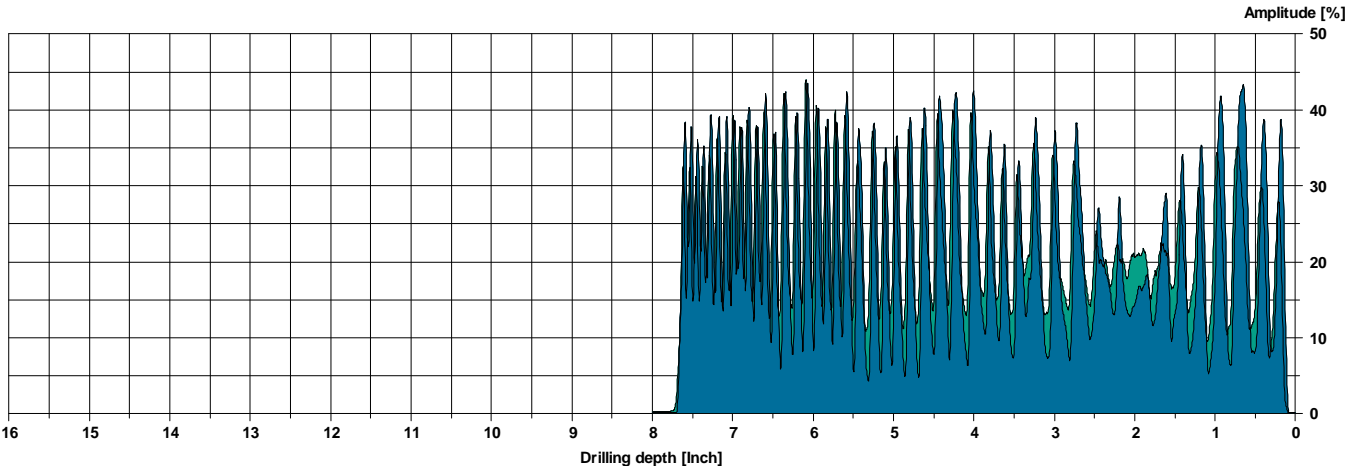
Drill: E-1023-13

**Span: 1    Member: Beam 1**  
**Location: 10' from the south abutment.**  
**Inspector Interpreted Profile:**  
No rot detected.

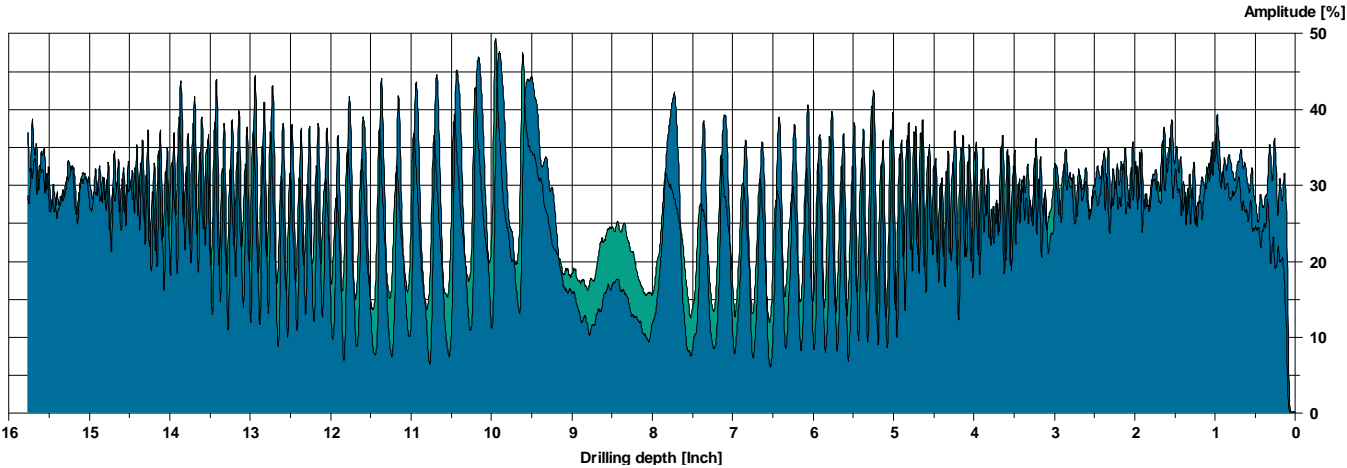
Drill: E-1023-14

**Span: 1    Member: Beam 1**  
**Location: 10' from the south abutment.**  
**Inspector Interpreted Profile:**  
No rot detected.

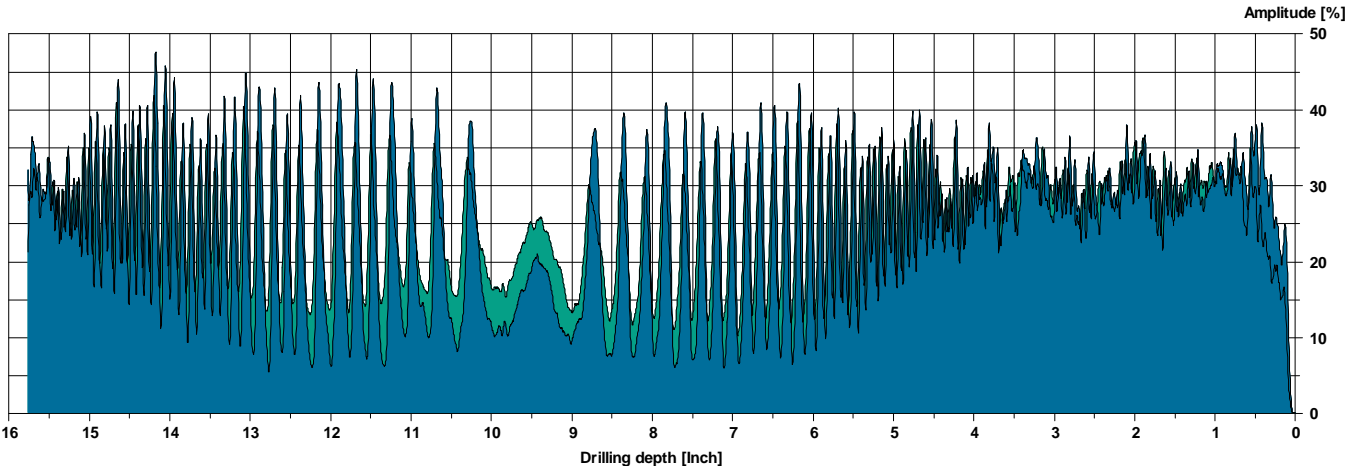
Drill: E-1023-15

Span: 1    Member: Beam 1  
Location: 13' from the south abutment.  
Inspector Interpreted Profile:  
No rot detected.

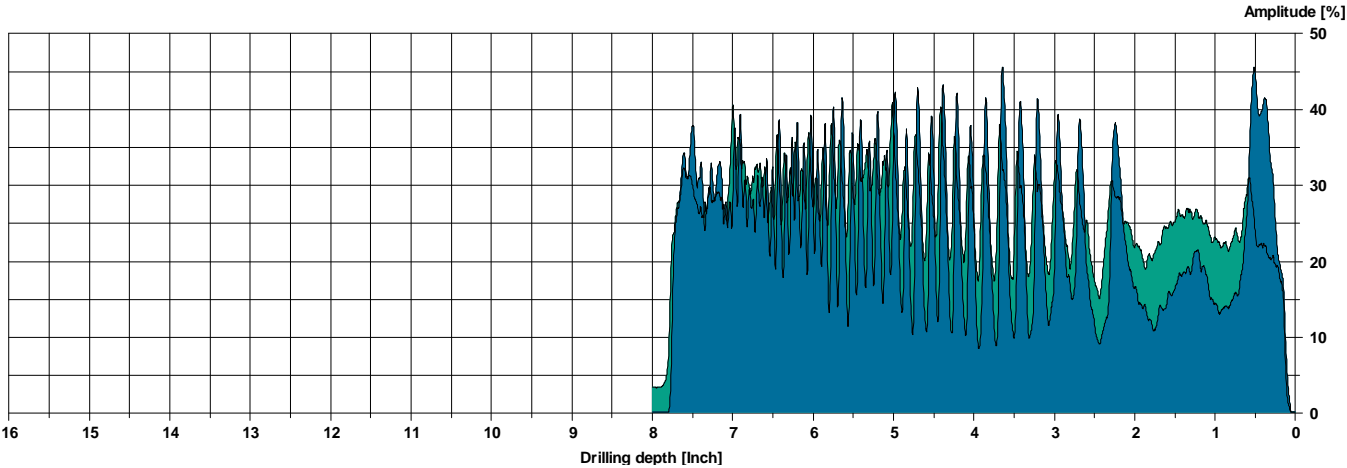
Drill: E-1023-16

Span: 1    Member: Beam 1  
Location: 13' from the south abutment.  
Inspector Interpreted Profile:  
No rot detected.

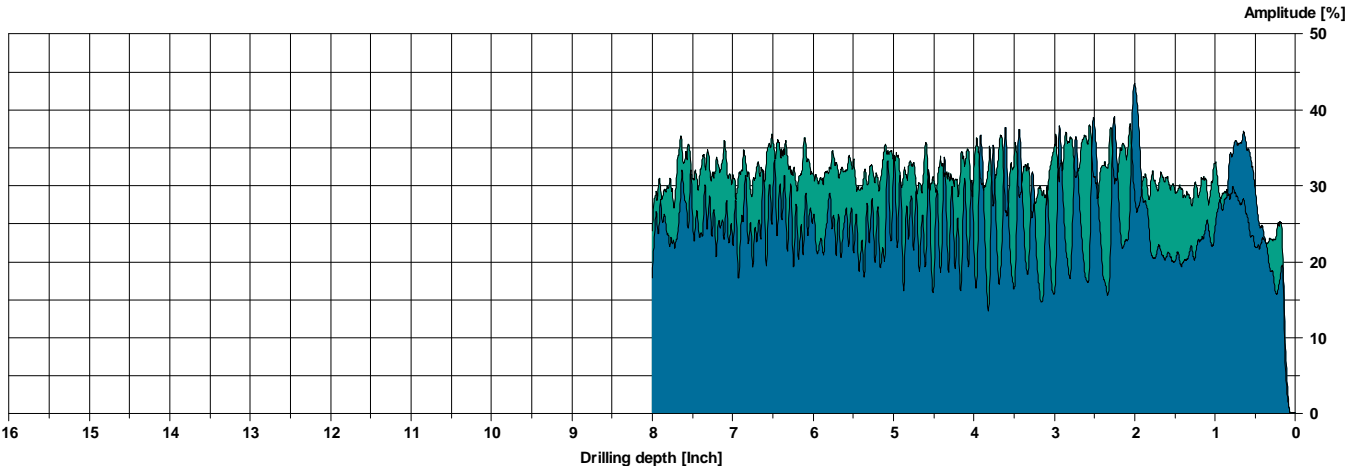
Drill: E-1023-17

Span: 1 Member: Beam 1  
Location: 16' from the south abutment.  
Inspector Interpreted Profile:  
No rot detected.

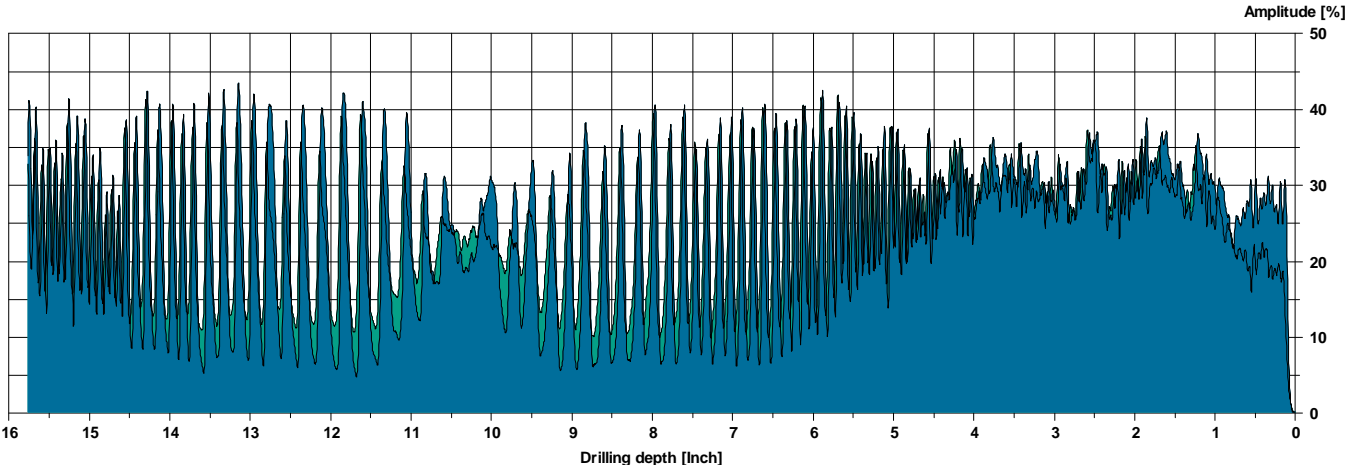
Drill: E-1023-18

Span: 1 Member: Beam 1  
Location: 16' from the south abutment.  
Inspector Interpreted Profile:  
No rot detected.

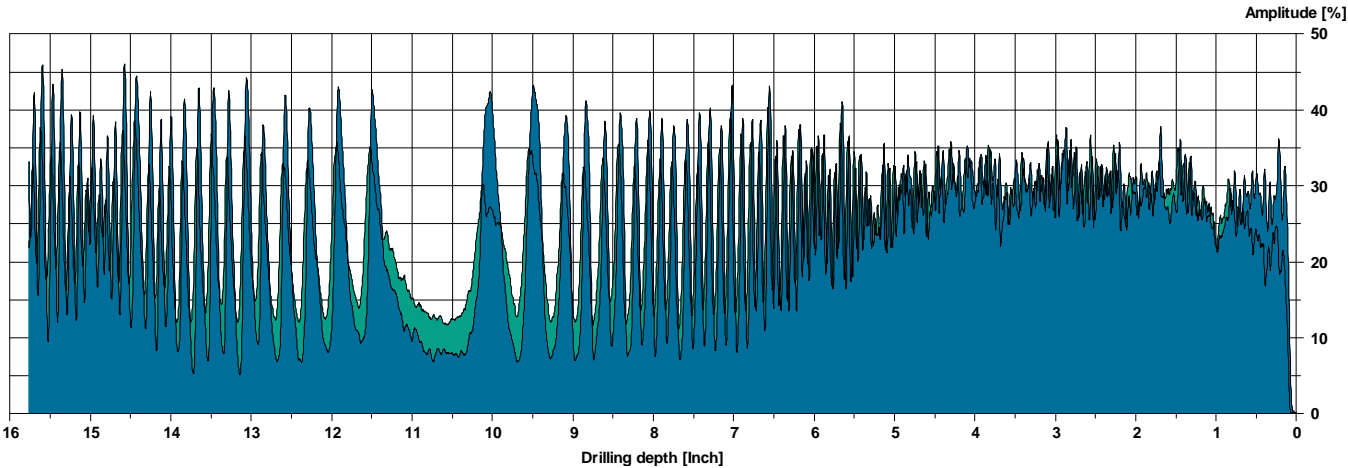
Drill: E-1023-19

Span: 1    Member: Beam 1  
Location: 19' from the south abutment.  
Inspector Interpreted Profile:  
No rot detected.

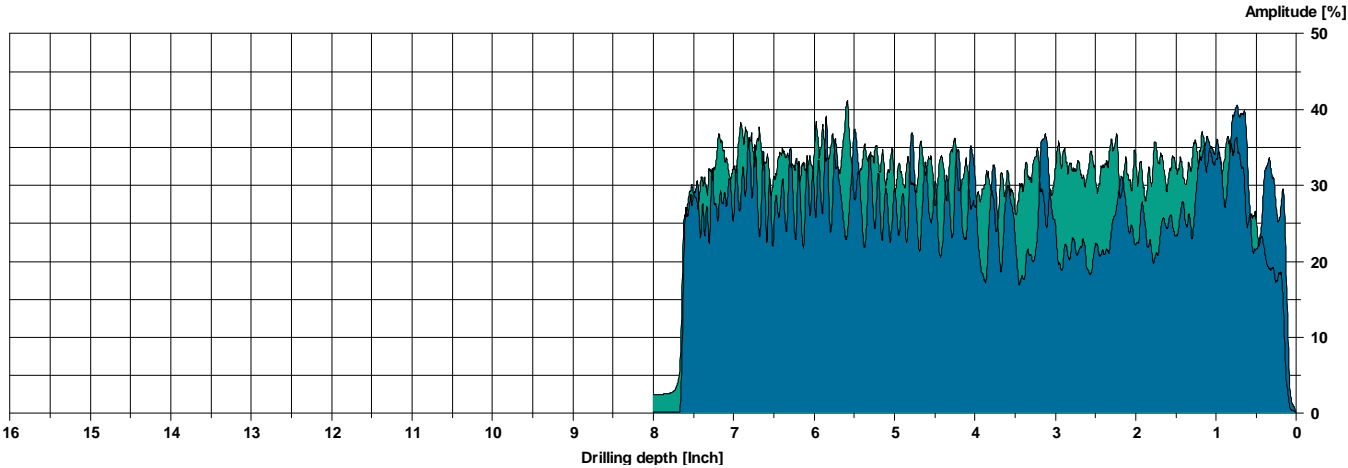
Drill: E-1023-20

Span: 1    Member: Beam 1  
Location: 19' from the south abutment.  
Inspector Interpreted Profile:  
No rot detected.

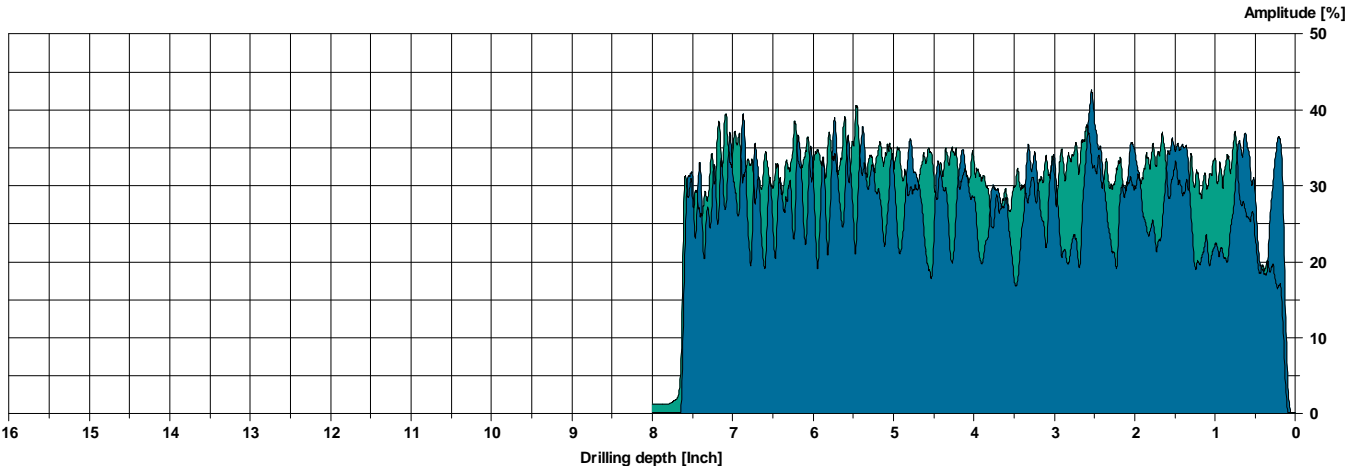
Drill: E-1023-21

**Span: 1    Member: Beam 1**  
**Location: 22' from the south abutment.**  
**Inspector Interpreted Profile:**  
No rot detected.

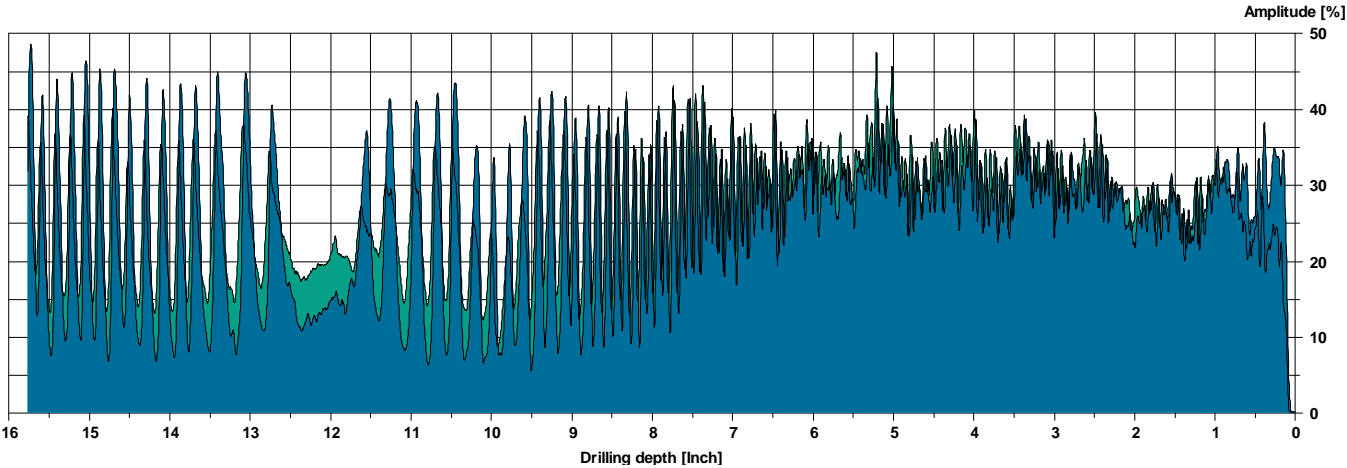
Drill: E-1023-22

**Span: 1    Member: Beam 1**  
**Location: 22' from the south abutment.**  
**Inspector Interpreted Profile:**  
No rot detected.

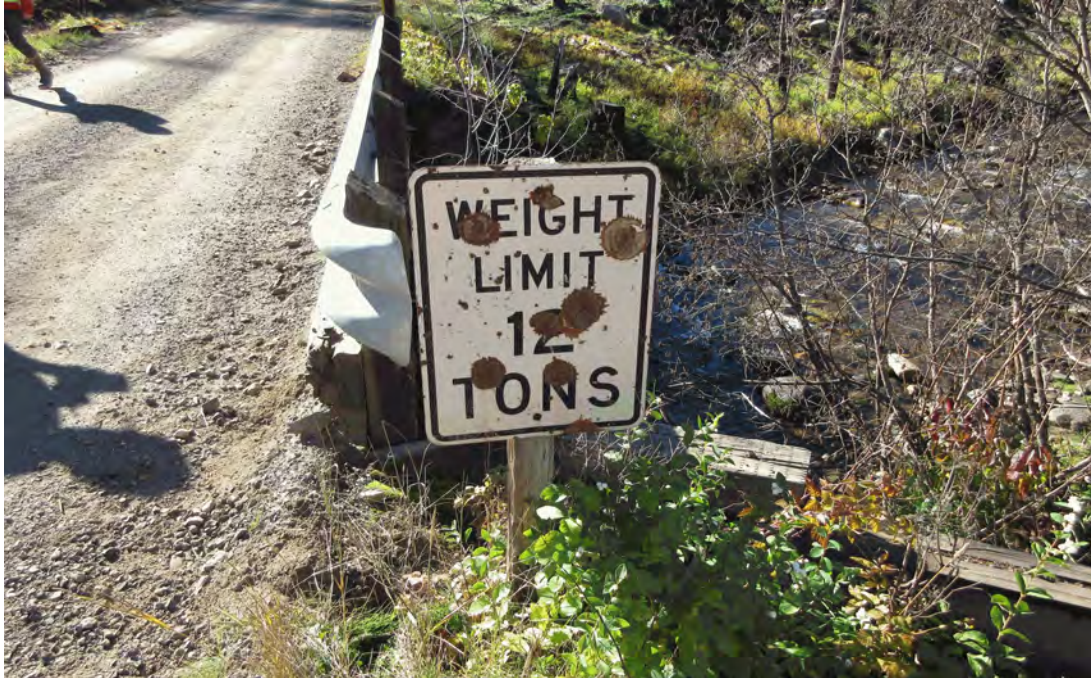
North approach: the old [WEIGHT LIMIT 12 TONS] sign which was later replaced.

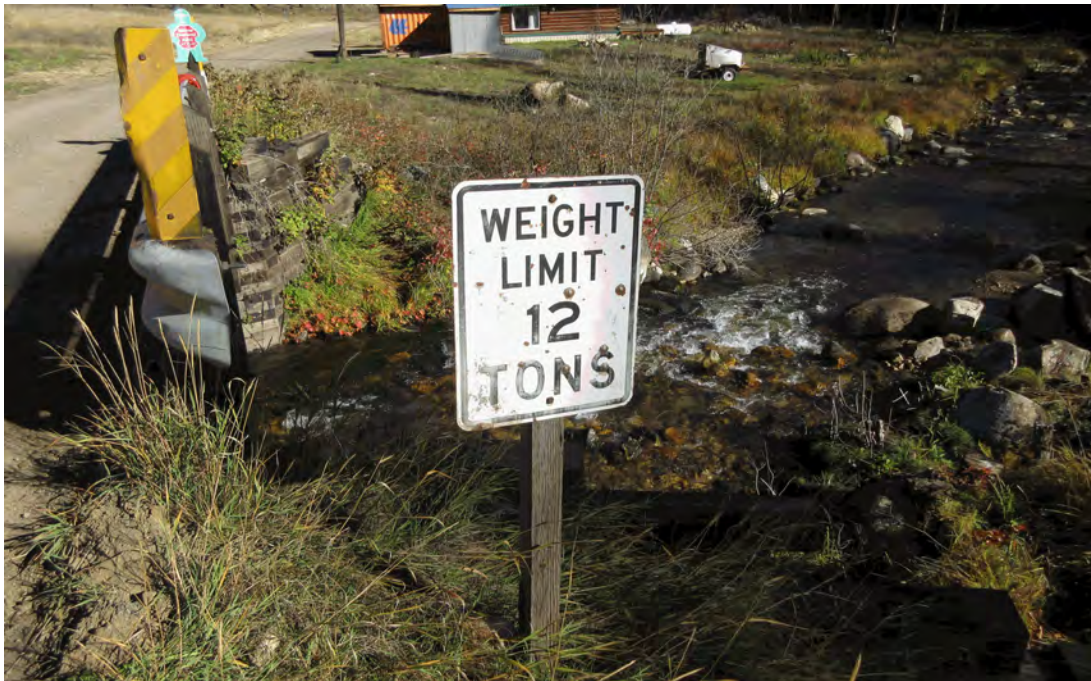
South approach: the old [WEIGHT LIMIT 12 TONS] sign which was later replaced.

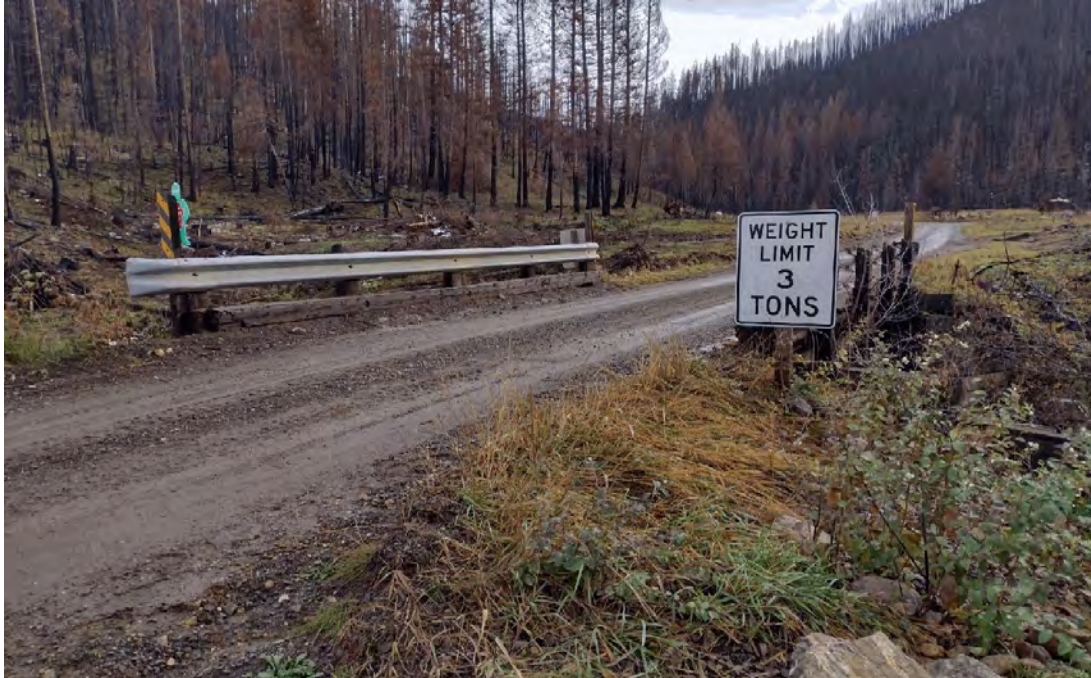
11/2/2023: North approach new [WEIGHT LIMIT 12 TONS] sign.

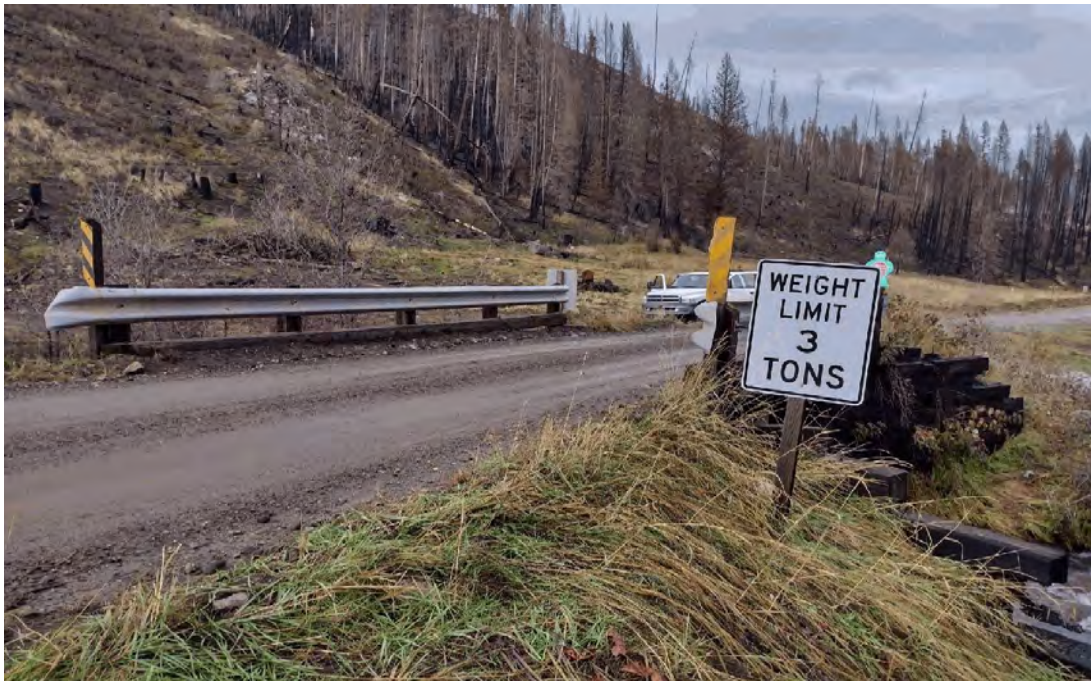
11/2/2023: South approach new [WEIGHT LIMIT 12 TONS] sign.
